## 523 N. Donnelly Street

### Rehabilitation Proposal

Preservation Rehabilitation-HIPR-734-OL

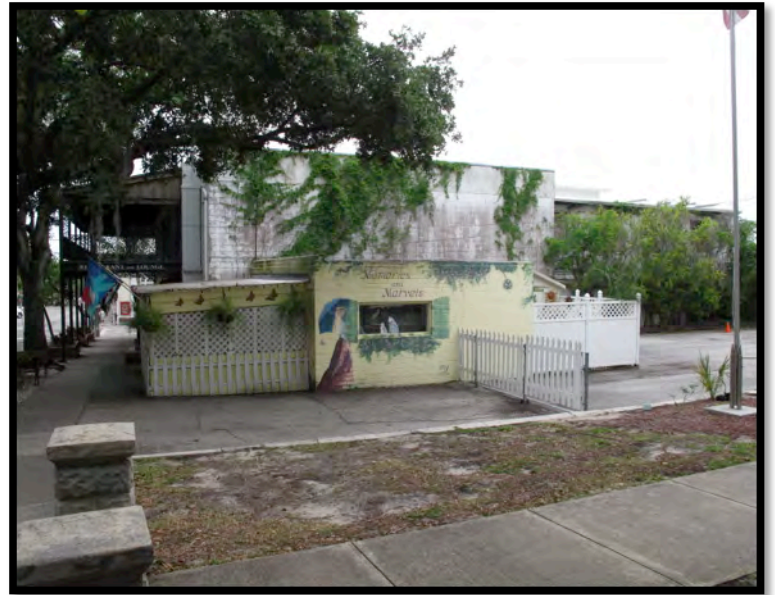
**Fig. 2.3** Mildew and overgrowth of vegetation have taken over most of the north façade.

The building's exterior fabric is in decent condition, while the interior condition is very poor, due to excessive water damage and a decade or more of neglect. The damage appears to be caused by damage from the roof. On the north façade there is slight overgrowth and vegetation (Fig. 2.3).

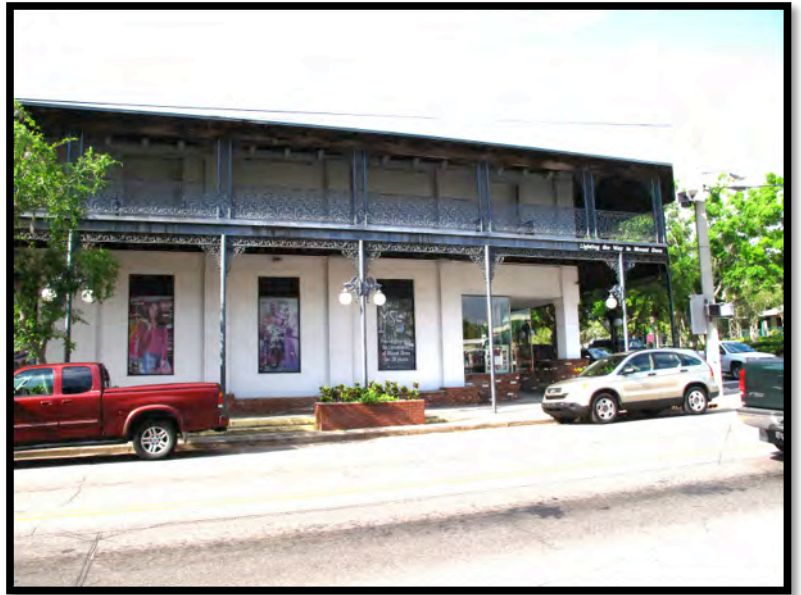
**Fig. 2.5** The south façade, on Fifth Avenue, appears to be in good condition

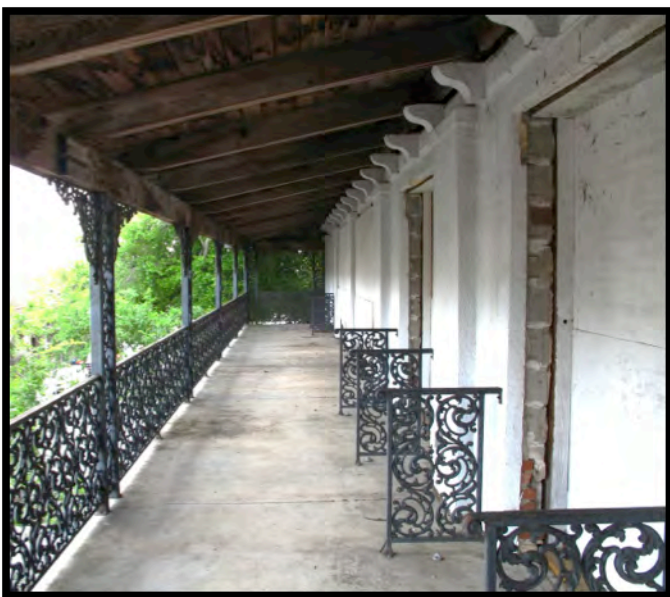
The intricately designed cast-iron balcony on the second-floor spans from the Fifth Avenue façade (Fig. 2.6) and wraps around to the Donnelly Street façade (Fig 2.7). It is accessible from two doors on the Donnelly Street façade and four doors on the Fifth Avenue façade. Although not an original element of the building, it has further added to the character of the building and the town. The concrete flooring of the balcony has also been affected by the pervasive water damage, which is evident in mildewed areas and various cracks.

**Fig. 2.6** Second-floor balcony on Fifth Avenue looking west. The stucco around the doorway has been damaged from water damage. Rafters and eaves above are also damaged from excess moisture.

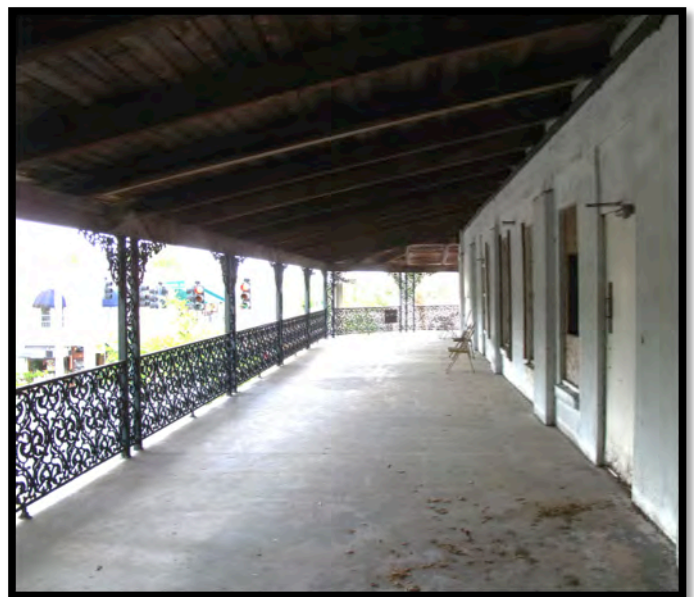
**Fig. 2.7** Second-floor balcony on Donnelly Street, looking north. Extensive water damage has affected the rafters and eaves of the building.

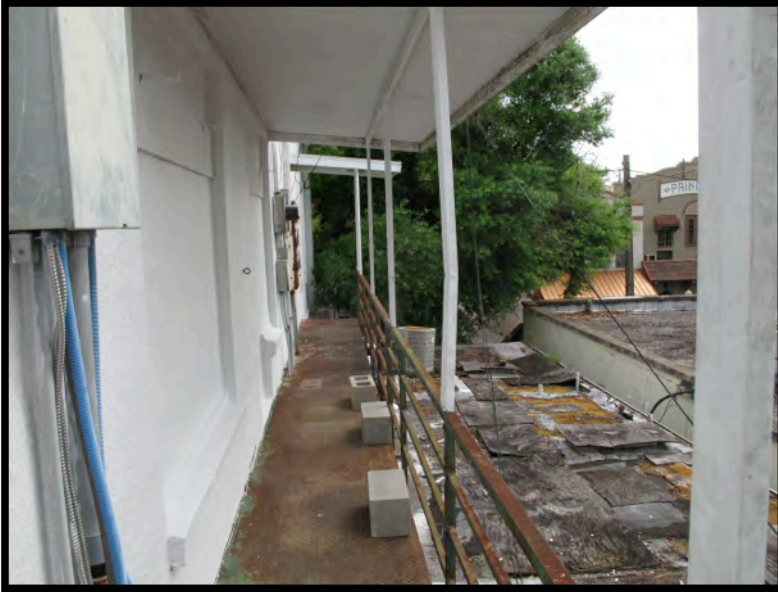
**Fig. 2.8** Rusted iron balcony on the west façade. The roof of the rear bathrooms, to the right, is situated in a connected outbuilding

There is a rear, exterior metal staircase (Fig. 2.8, 2.9) that is accessible from the street level of Fifth Avenue and leads to the second-floor rear entrance/exit. It is completely rusted from the elements and years of neglect.

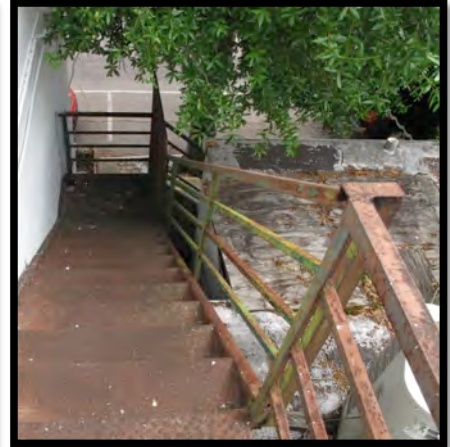
**Fig. 2.9** The rusted iron stairs leading from the street level to the second-floor access door.

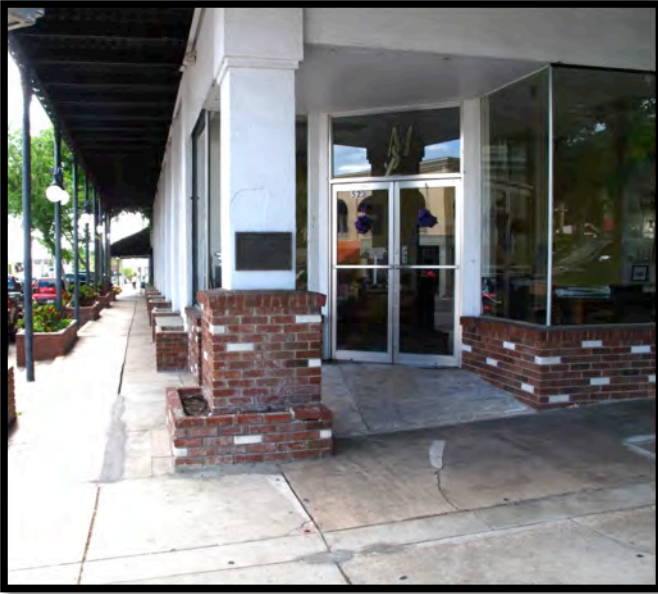
**Fig. 2.10** Corner main entrance. Plate-glass windows and doors are in good condition.

The angled, main corner entrance (Fig. 2.10) has two large 4' x 5' spans of plate-glass windows flanking the main entrance, above which is a 3' x 6' plate-glass transom. All of these windows are in good condition.

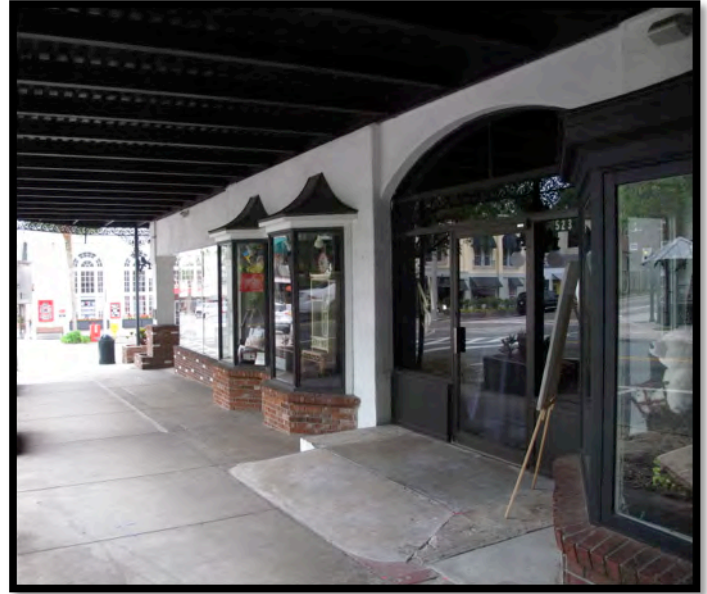
**Fig. 2.11** The enclosed former alcove and the twin, extended bay windows on the ground floor facing Donnelly Street. The ground floor of the exterior is in good condition for the most part.

On the ground floor, facing Donnelly Street, 5' x 5' spans of plate-glass windows continue for 2 window spans (Fig. 2.11). Immediately following the windows are two 2' projected, plate-glass bay windows in aluminum-clad frames – two sets of three 2' x 5' windows joined by a 2' x 5' plate-glass window encased in an aluminum-clad frame (Fig. 2.11). After the bay windows is the secondary entrance, which is the enclosed former alcove. Two 3' x 4' spans of plate-glass windows flank the single entry, full glass door, while a 1' x 9' plate-glass transom sits above the two windows and door, with an arched transom of 2' radius x 9' base (all are encased in aluminum-clad frames) (Fig. 2.11). Immediately following this set of windows is another 4' projected, plate-glass bay window with two 2' x 4' windows and three 3' x 4' windows (also encased in aluminum-clad frames) (Fig. 2.17). All of these windows are in good condition.

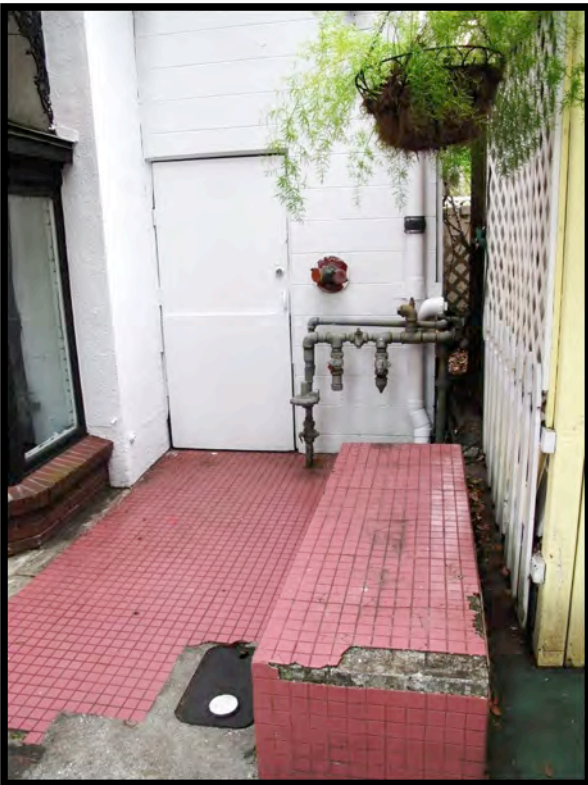
**Fig. 2.12** Access door on the ground floor of the northeast corner of the Donnelly Street façade. Exterior tiling has been worn down.

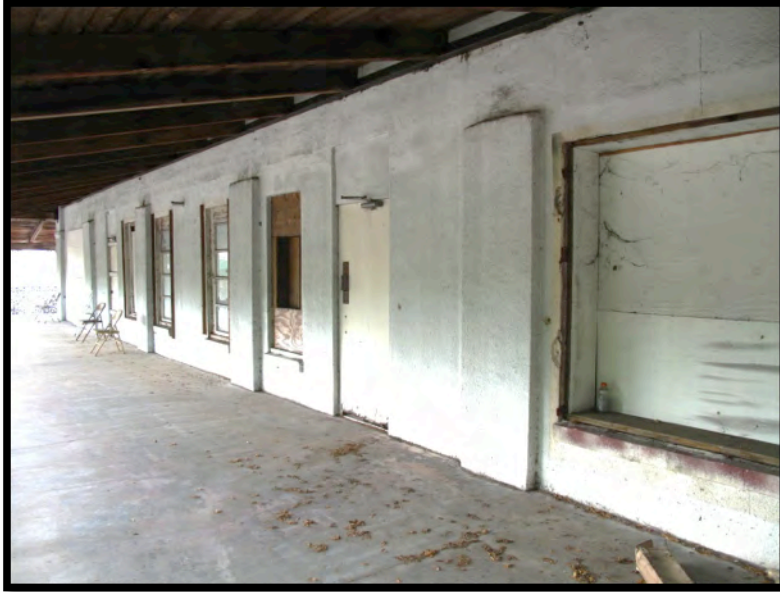
**Fig. 2.13** Windows and doors on the second-floor of the east façade, facing Donnelly Street. The door to the to the far left is blocked from opening. There are four windows and/or frames in the middle and another 4' x 6' window to the far left.

On the second floor, facing Donnelly Street, there are two flat paneled 3' x 6'-6", wood, swing doors (Fig. 2.13). The door to the north is in very bad condition and literally falling apart, while the door to the south has been boarded up.

On the second floor, facing Donnelly Street, there are two 4' x 5' wood frames (originally plate-glass windows that have since been removed and boarded with plywood) on either side of the façade, flanking four 2-1/2' x 4' wood frames (originally four-paned wood windows) in the middle. Only two of the 2.5' x 4' four paneled, light paned windows remain and they are in poor and deteriorating condition (Fig. 2.18, 2.19). The other two windows have been boarded with plywood (Fig. 2.13).

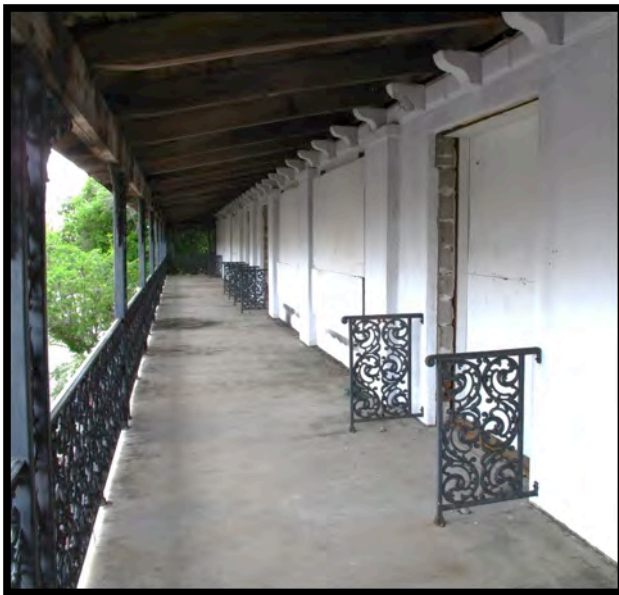
**Fig. 2.15** Windows and doors on the second floor of the south façade. Concrete blocks are exposed to the exterior.

plywood (Fig. 2.15). The concrete block is exposed as the doorways are unfinished, and the stucco is cracked and unfinished along the facing edges.

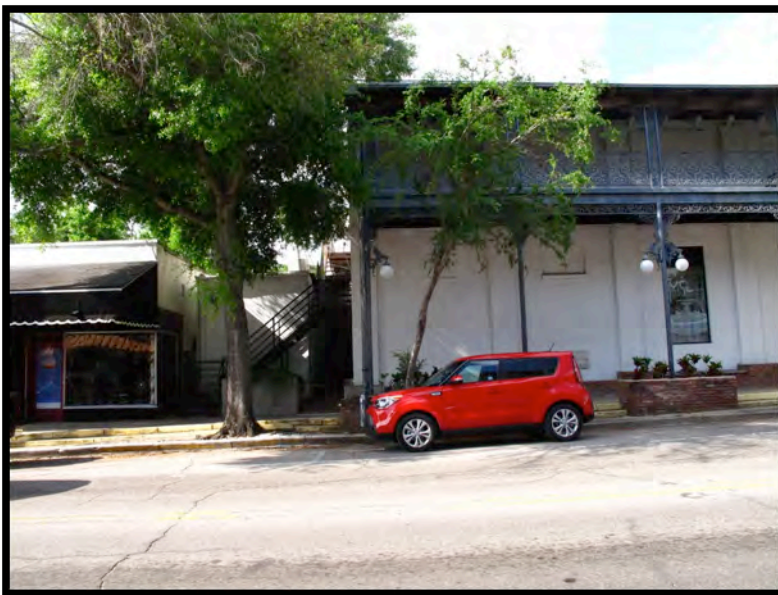
**Fig. 2.16** The remaining original two windows are boarded with plywood at the southwest corner on Fifth Avenue.

main corner entrance is approached, there is a large 4' x 5' span of plate-glass (Fig. 2.5). Minus the original, boarded windows to the southwest corner that have been boarded with plywood, the other windows are in good condition.

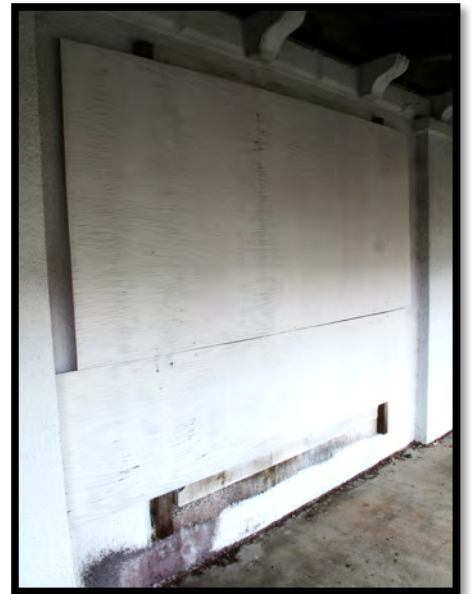
**Fig. 2.20** Mildew from water damage under one of the boarded windows on the second-floor of the south façade.

On the second floor, facing Fifth Avenue, there are four 4' x 5' windows that are boarded with plywood (Fig. 2.20). It is difficult to distinguish the condition of windows as they are boarded on both the interior and exterior sides.

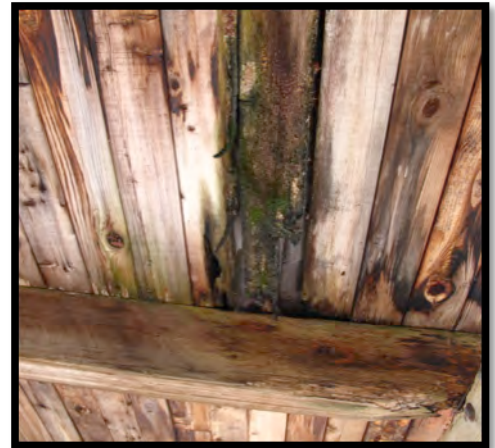
The wood rafters of the building are spaced 2' apart from one another as they span along both Fifth Avenue and Donnelly Street. The eaves of Fifth Avenue overhang about 7' while the eaves of Donnelly Street overhang about 13'. These are unfinished and because of the considerable water damage they have mostly rotted (Fig. 2.21).

**Fig. 2.21** Water damage on the rafters and eaves.

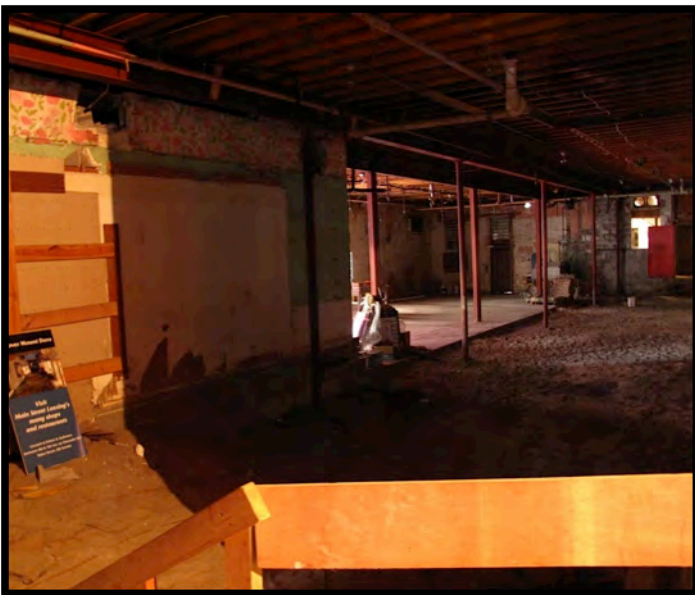
**Fig. 2.22** Main Street Leasing's makeshift office space is to the left. Walls are heavily damaged and a rectangular portion of the floor is missing. The ceiling is unfinished.

The ground floors consisted of a concrete slab foundation, but to date a large piece of the floor is missing and only dirt remains (Fig. 2.22). The original floor systems of the second-floor were wood floors supported by piers, which can still be seen, although now there are several parts of the floor missing and sheets of plywood have been laid down on the floor to provide 'safe' access (Fig. 2.29).

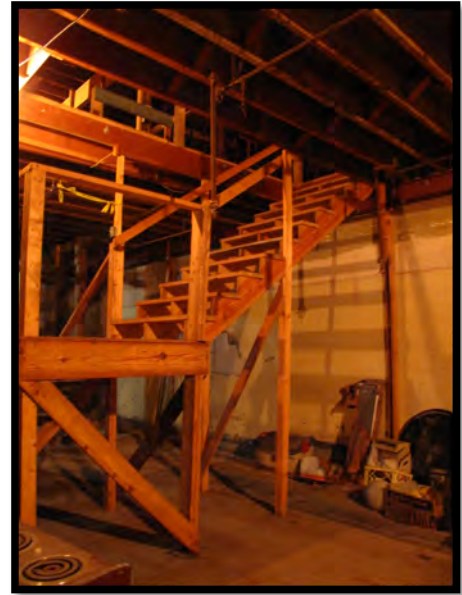
The original staircase has long been removed and the current wood staircase leading to the second-floor is makeshift (Fig. 2.28) as it was constructed for temporary access until the new staircase could be built; unfortunately it has been in existence since 2008. Construction had commenced on the concrete block encasement for the new stairway (Fig. 2.27) some years ago, but it has not been completed.

**Fig. 2.28** Makeshift staircase.

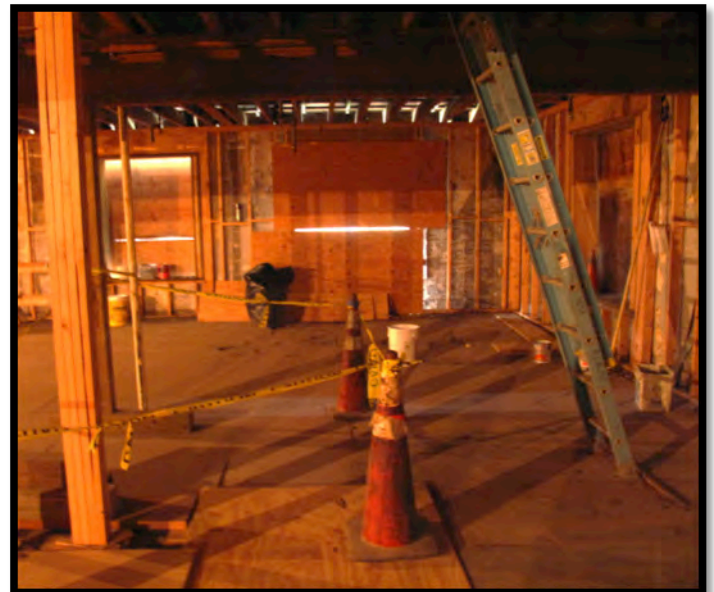
**Fig. 2.29** Southwest corner on the second-floor. The wood subfloor is covered with plywood where flooring is missing. The roof is accessible from the ladder

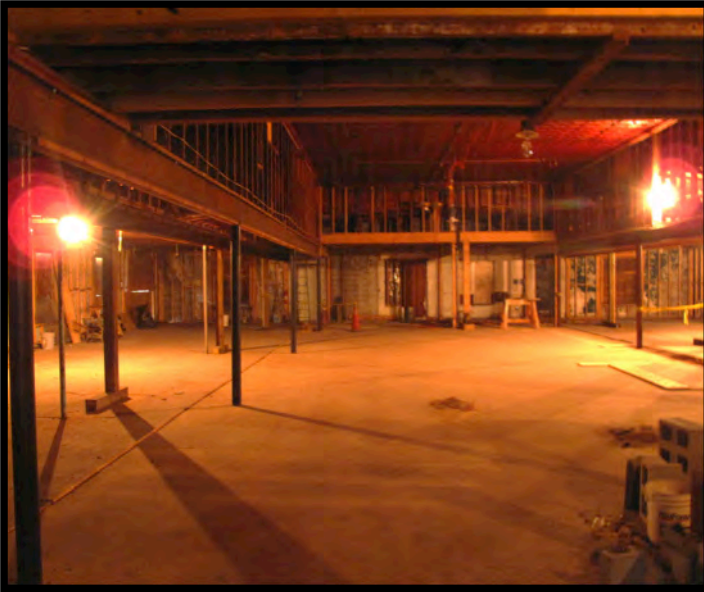
**Fig. 2.30** On the ground floor, looking at the north wall that has an interior window frame on the interior. The wall is in horrible condition.

The extensive water damage throughout the building has left the walls and ceilings completely unfinished (Fig 2.30 - 2.36). The walls are a hodge-podge of wallpapers and colors with the marks of water damage, while the ground floor ceiling is exposed to overhead joists and beams. The second-floor walls are in the same condition as the walls on the ground floor, and concrete blocks are visible in many parts of the building. The ceiling is completely unfinished, open to the joists and beams above. Only in the center of the open area is the original tin stamp ceiling.

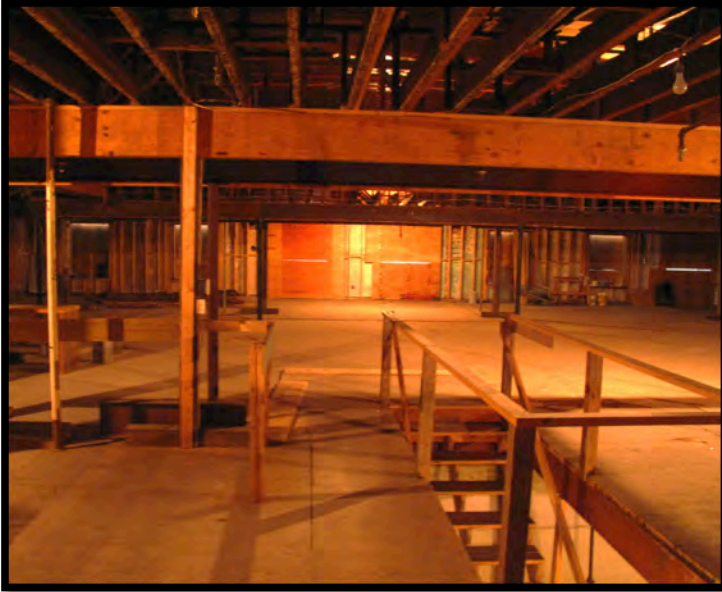
**Fig. 2.33** The second-floor, looking to the south wall, is completely unfinished and exposed.

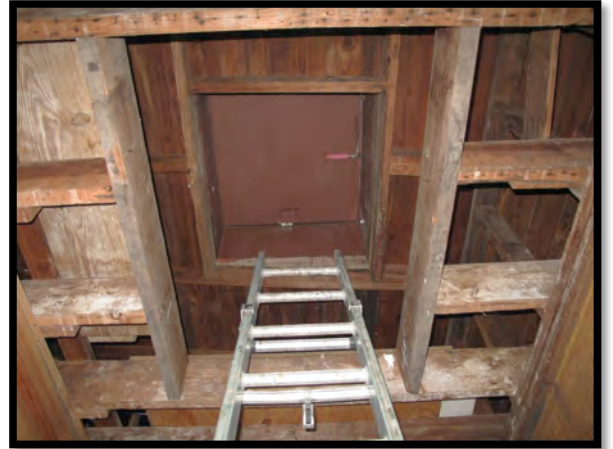
**Fig. 34** The roof is accessed through this opening and the use of a ladder. The water damage is evident in the joists above.

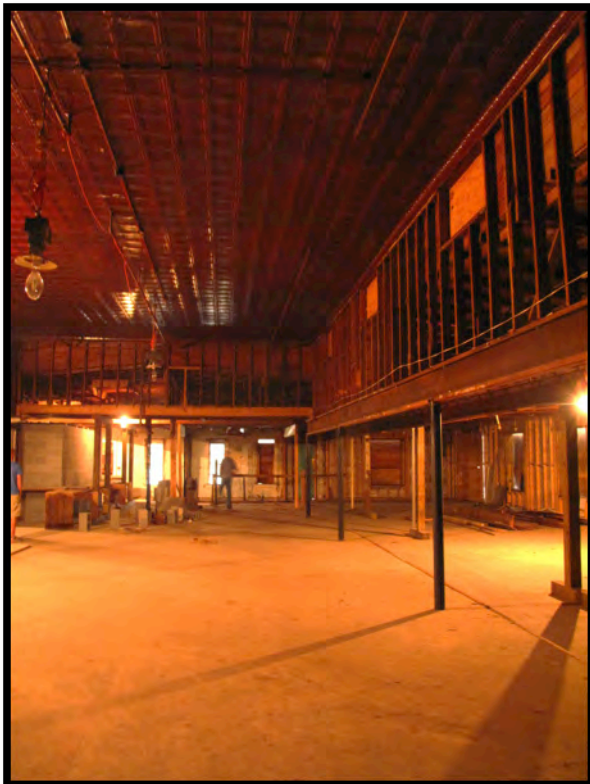
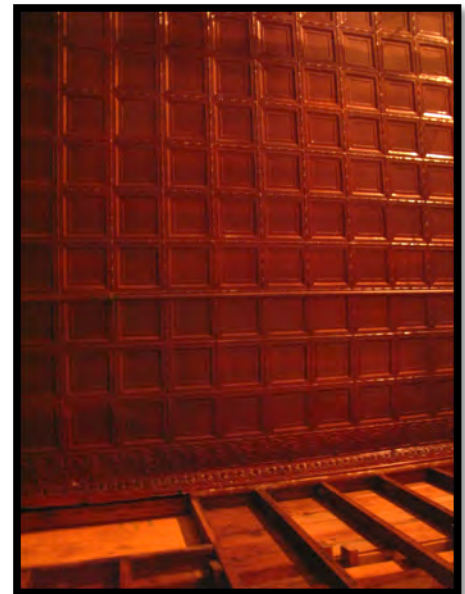
**Fig. 2.35** In the central area of the second-floor. The tin stamped ceiling can be seen above, but the area is unfinished.

The only decorative feature that remains is the tin stamped ceiling (Fig. 2.35, 2.36). The majority of it can be found on the second-floor, while only a very small and deteriorated section remains on the ground floor.

Once water damage has been mitigated, the interiors will need to be finished, from the floors to the walls, ceilings to the windows and doors. The stamped tin ceiling on the second-floor will need to be carefully removed for the time being while interior work is being carried out. Drywall will need to be mounted to all ceilings and interior walls, puttied and then painted. The missing section of concrete on the ground floor will need to be replaced and then all the floors will need to be finished, and on the second-floor missing pieces of floorboard will need to be replaced and then finished. Windows and doors will need to be replaced completely on the second-floor and only where necessary on the ground floor. Basics such as electrical wiring and fixtures will need to be installed, an appropriate HVAC system laid out and plumbing as two bathrooms will be introduced into every designated space (bookstore, farmer's market and restaurant/bar).

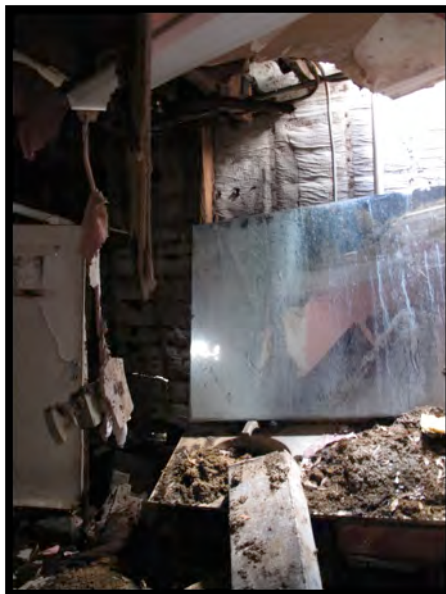
**Fig. 2.39** (bottom middle) The women's bathroom, facing the west wall, has experienced extreme water damage.

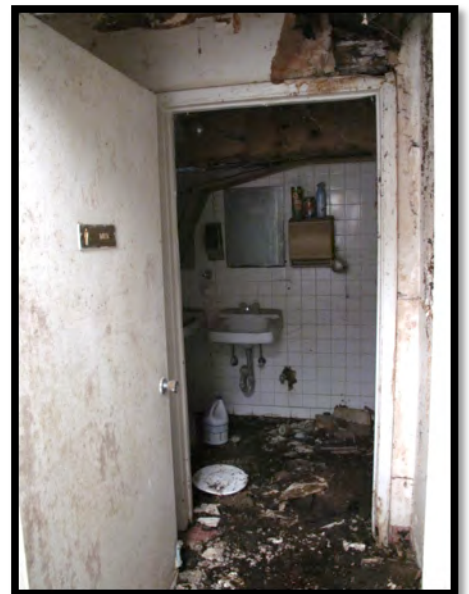
**Fig. 2.40** (bottom right) The men's bathroom is also in deplorable condition.
