Annie M. Pfeiffer Chapel, Florida Southern College, Lakeland, Florida. *Robin Hill*,
<http://www.photoshopshowcase.com/ViewFlashMedia.aspx?AID=110446&AT=3>

Child of the Sun: A Crumbling History Preserved

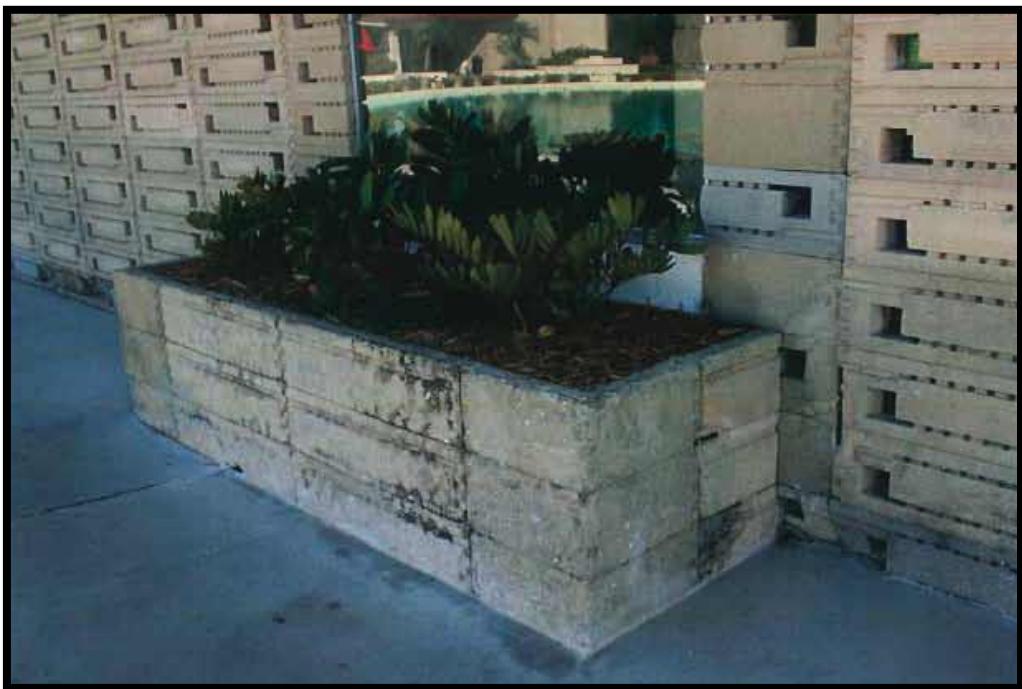
Fig. 13 Damage to the Three Seminars is inclusive to widespread discoloration, deterioration and biological staining from moisture damage. *Mesick Cohen Wilson Baker Architects*

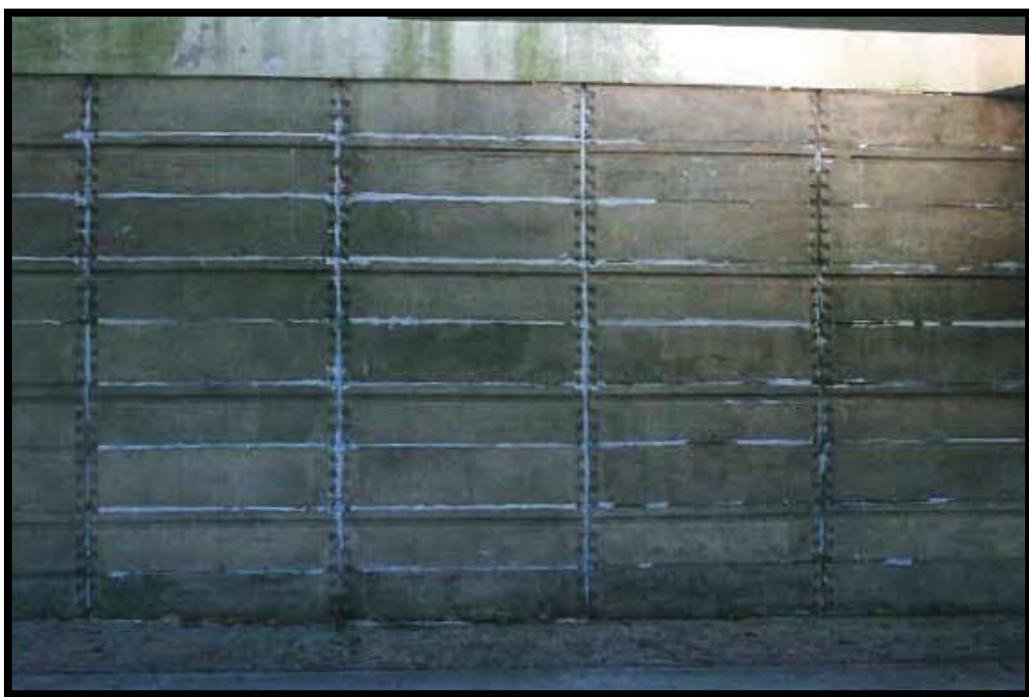
Fig. 15 E.T. Roux Library, east façade displays improper repairs through use of sealant and biological staining. *Mesick Cohen Wilson Baker Architects*.

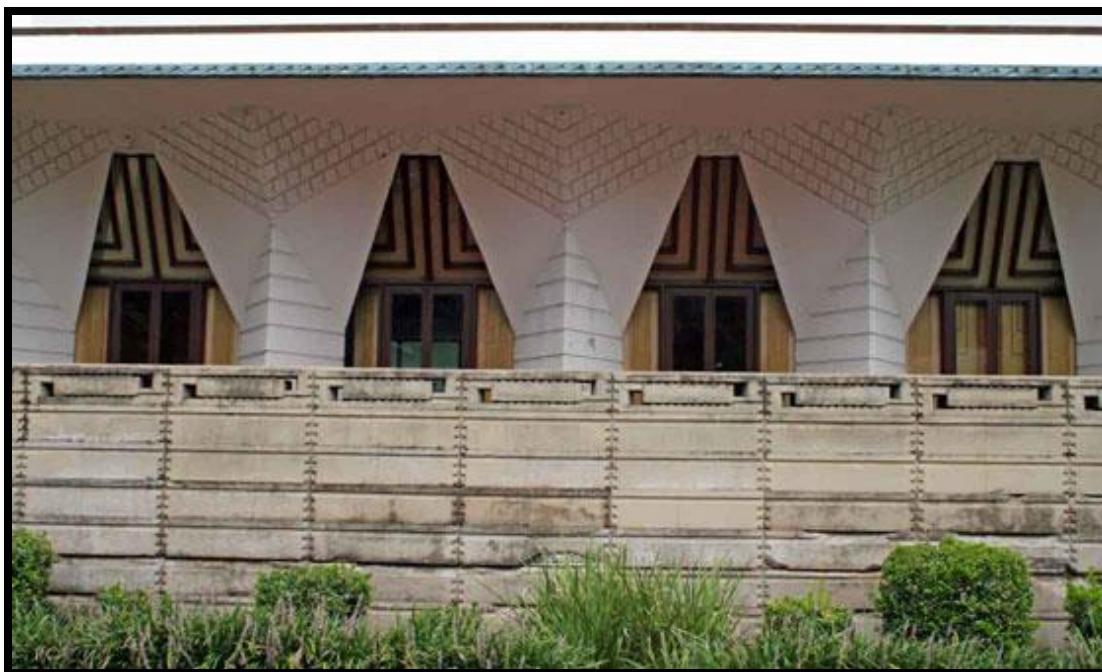
Fig. 17 The Emile E. Watson Administration Building, completed in 1949. The exterior block wall is severely cracked and deteriorating. *Augustus Mayhew, The New York Social Diary, <http://www.newyorksocialdiary.com/node/920187>*.

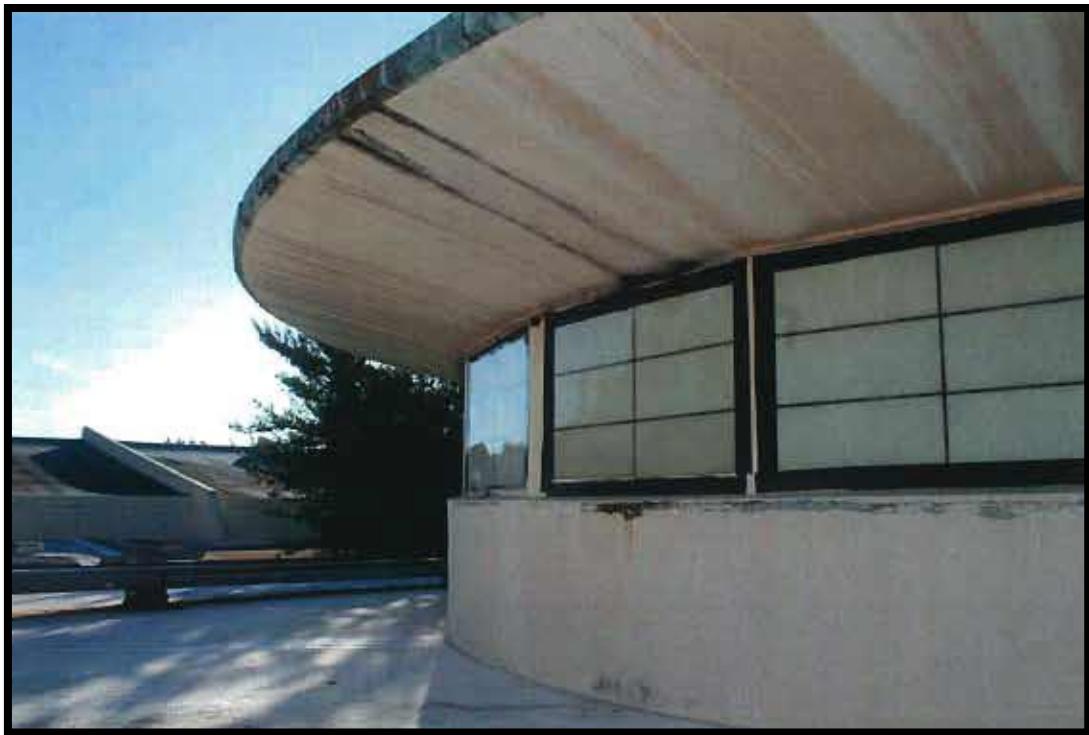
Fig. 20 Fletcher Theater housed in the Industrial Arts Building, damage includes corrosion of metal elements and concrete deterioration. *Mesick Cohen Wilson Baker Architects.*

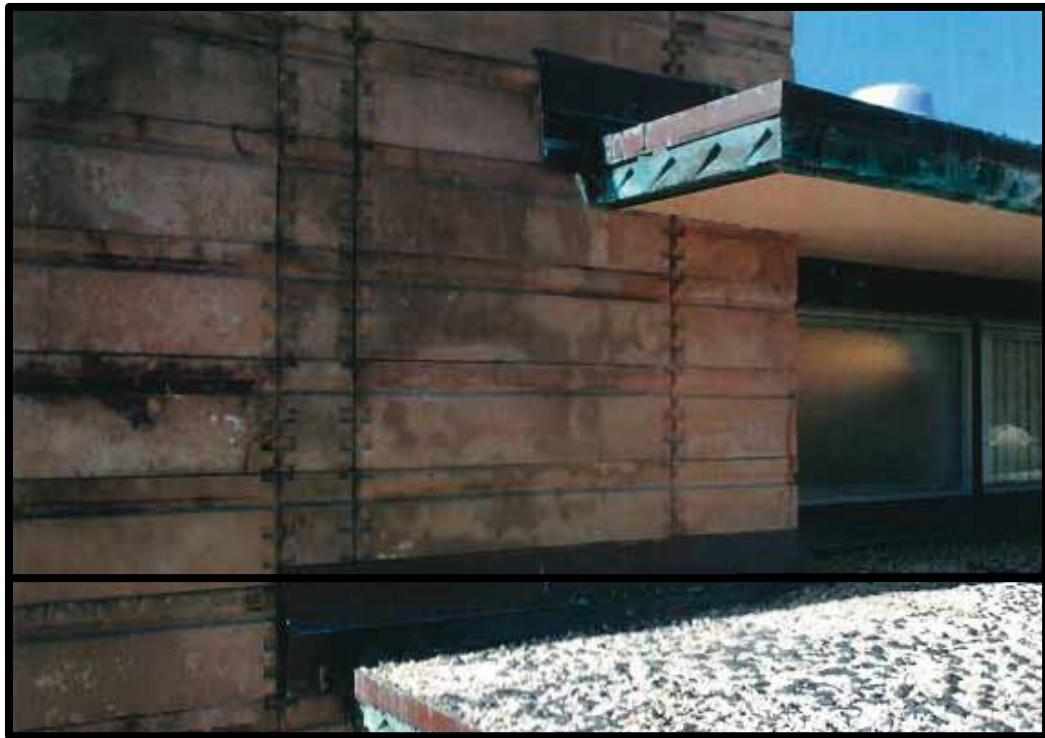
Fig. 22 Polk County Science Building, east façade shows biological staining and mold from moisture infiltration.
Mesick Cohen Wilson Baker Architects.

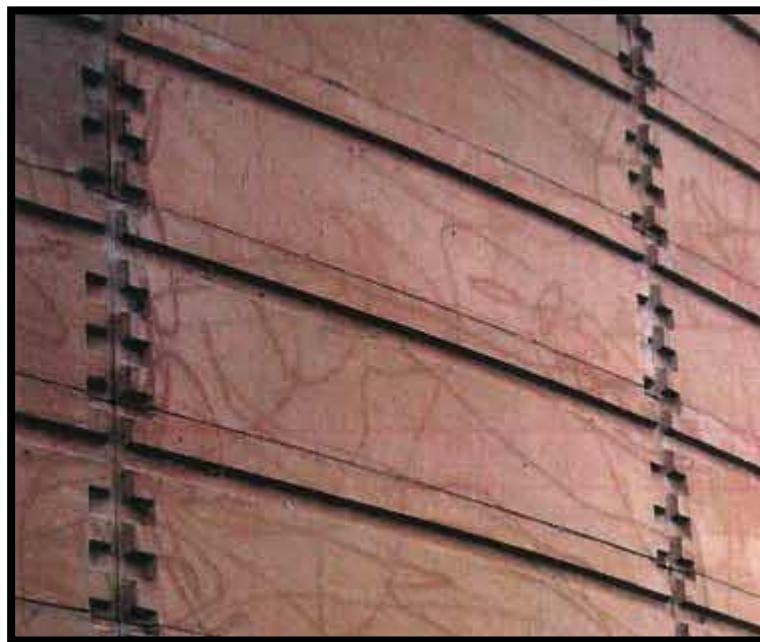
Fig. 23 Polk County Science Building, permanent damage from harsh pressure cleaning. *Mesick Cohen Wilson Baker Architects.*

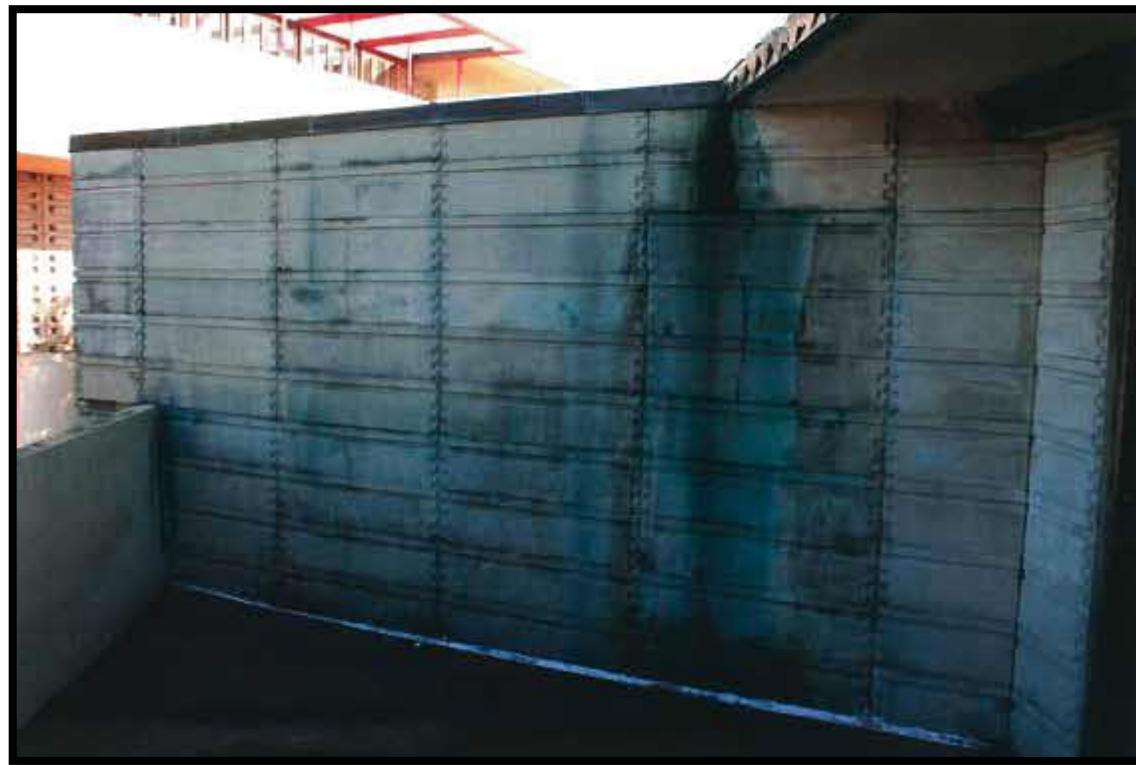
Fig. 25 William H. Danforth Chapel, east façade is host to biological staining, copper carbonate deposits, and improper repairs with sealant. *Mesick Cohen Wilson Baker Architects*.

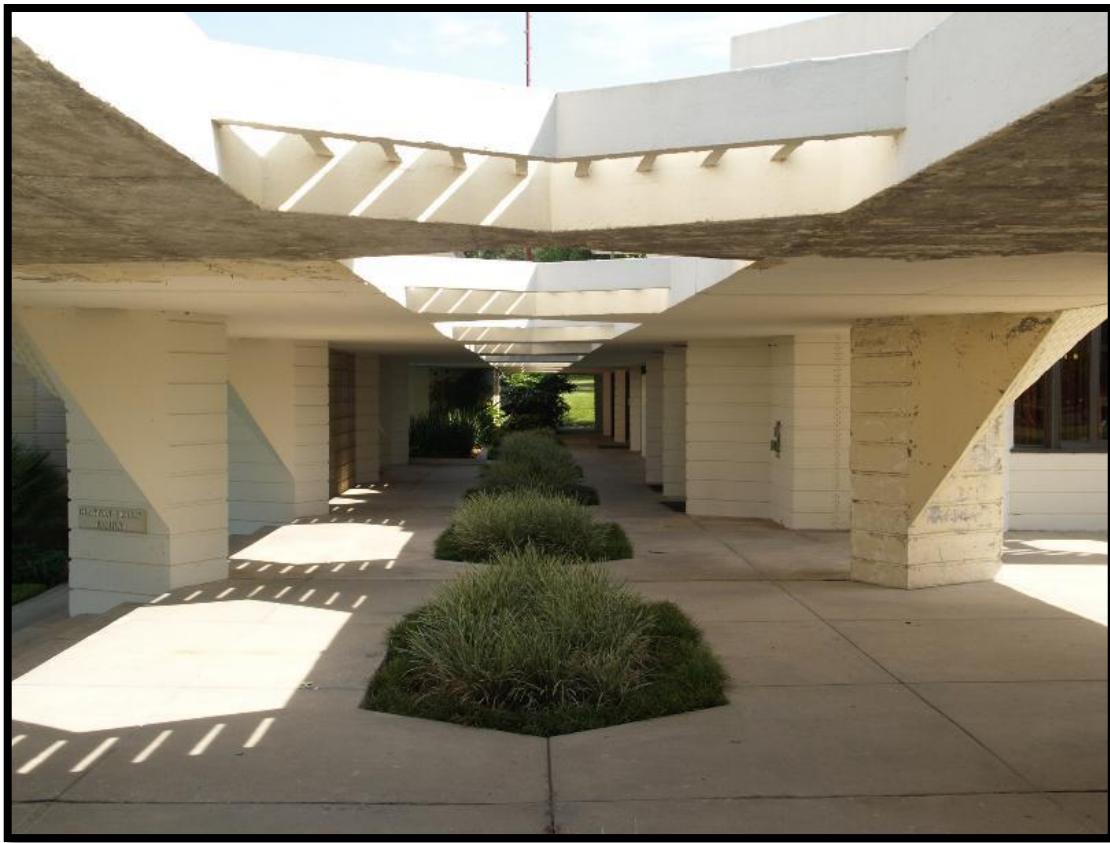
Fig. 26 View of an esplanade. The entire system of walkways was completed in the 1950s. There is evidence of biological staining on the ceiling, stripping of the paint and cracking due to lack of expansion joints. *Cambridge 2000 Gallery*, <http://www.cambridge2000.com/aallery/html/P72021532e.html>.

“Frank Lloyd Wright described this campus, at one point as a series of esplanades that occasionally became buildings.”¹⁹ As much importance as he weighed on the esplanades, he failed to properly construct them by not ensuring they would have expansion joints. This led to their ultimate deterioration, as they cracked in these exact areas where the expansion joints were necessary. Also the exposed steel reinforcements had created spalling at several points, which in turn had further depreciated the enveloping cement. For the restoration of the esplanades, the damage was well surveyed and documented. The cracks were addressed with hard or flexible epoxy repairs. All corroded and rusted steel reinforcement was consolidated at the spalled areas throughout and properly covered with cement. The

esplanades were repainted and patina applied where necessary. Site drainage was also improved in an attempt to slow and prevent future deteriorations.²⁰

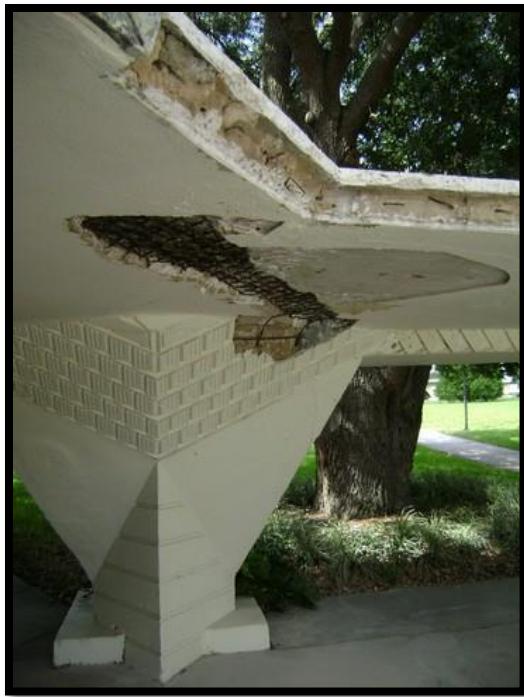
Fig. 27 Cracking, deterioration and sagging, as viewed in the esplanades, are caused by rusted and corroded steel reinforcement and the lack of design of expansion joints. *Mesick Cohen Wilson Baker Architects.*

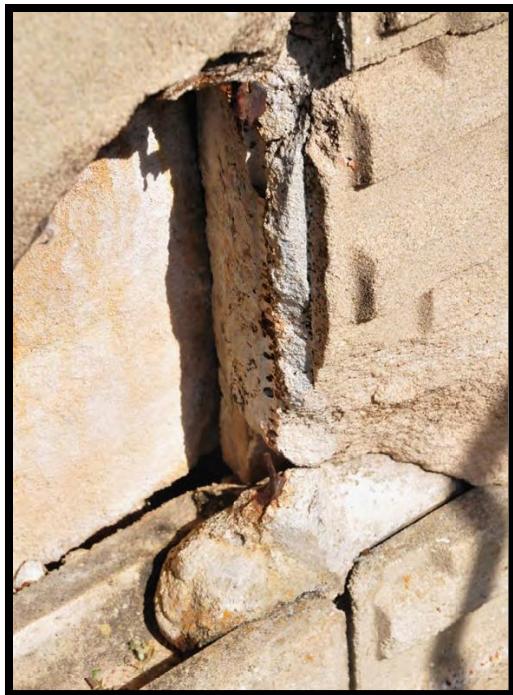
Fig. 28 The steel reinforcement has caused erosion, instigating the brick to lose its integrity, now highlighting the once hidden grout tubes. *Jeffrey M. Chusid, World Monument Fund.*

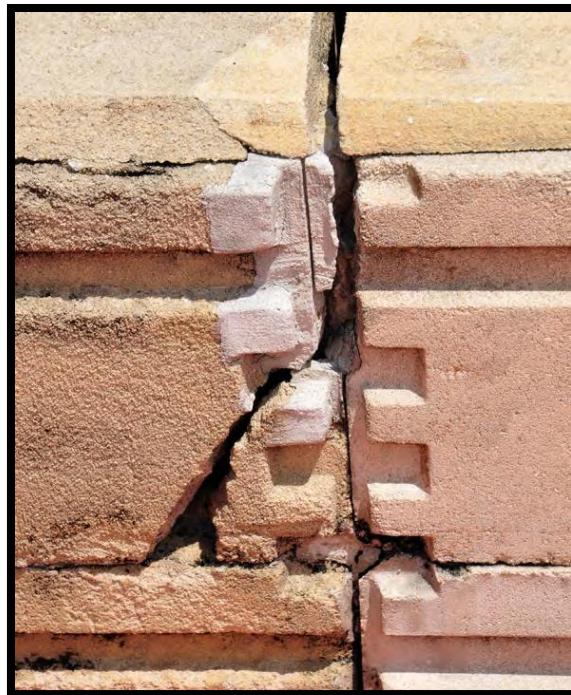
Fig. 29 Evidence of different mixes and replacements and/or patches of blocks. Attention is necessary to resolve these visual and structural blunders. *Jeffrey M. Chusid, World Monument Fund.*

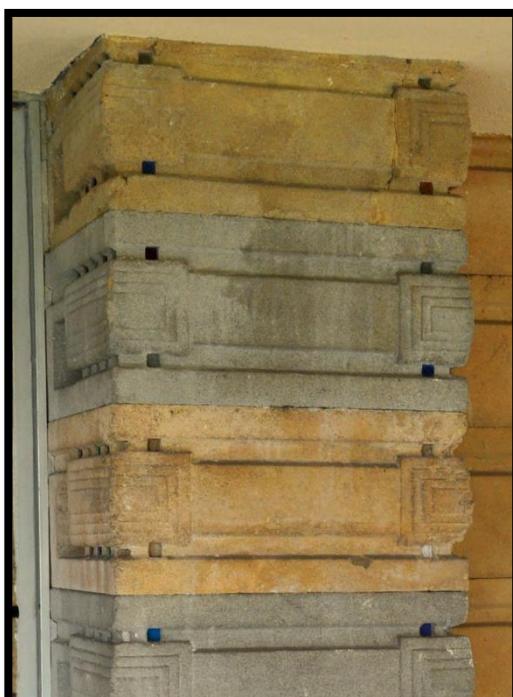
Fig. 30 Another example of discoloration due to different mixes and replacements of blocks. Also there are hints of biological staining and efflorescence. *Jeffrey M. Chusid, World Monument Fund.*

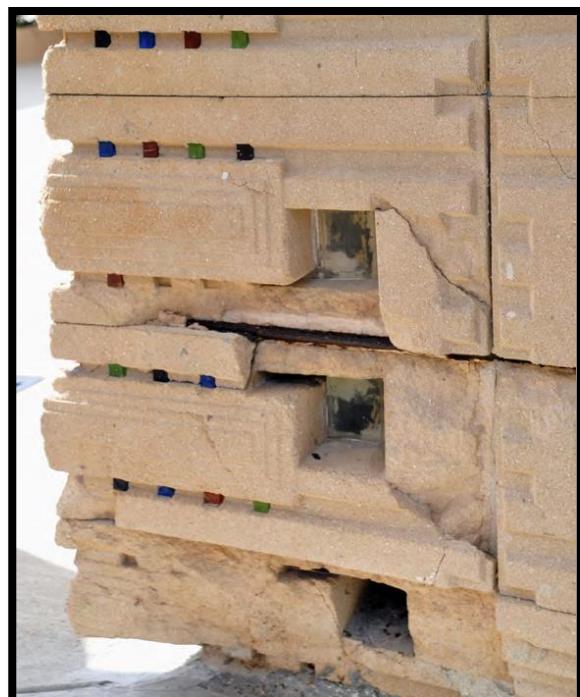
Fig. 31 Thermal expansion of the corner blocks has been a primary cause for the apparent cracking. The steel reinforcement is rusting and corroding, as well, causing the blocks to further deteriorate. *Jeffrey M. Chusid, World Monument Fund.*

The site conditions and changes of use throughout the years have had profound impacts on the buildings. Thermal expansion is a major problem developed from the lack of a mortar bed which appears to plague the corners of the buildings (Fig. 31). Wright did not leave room in his plan for HVAC systems, as he did not like air conditionning, but rather preferred nature.²⁹ Instead, he designed special ventilator blocks which allowed the air to travel through certain blocks of the buildings, but this has introduced serious moisture problems. Unfortunately for Wright, the college did not share this belief and HVAC systems were added to the buildings. They were “put in [unsightly locations] and new walls [were] created to hide mechanicals.”³⁰ Another issue is the collection of excess ground water from rainwater runoff. This poses a serious risk for those blocks nearer to the ground level. The water easily seeps through the unmortared joints, rusting the steel reinforcement and causing the blocks to crack under added pressure.

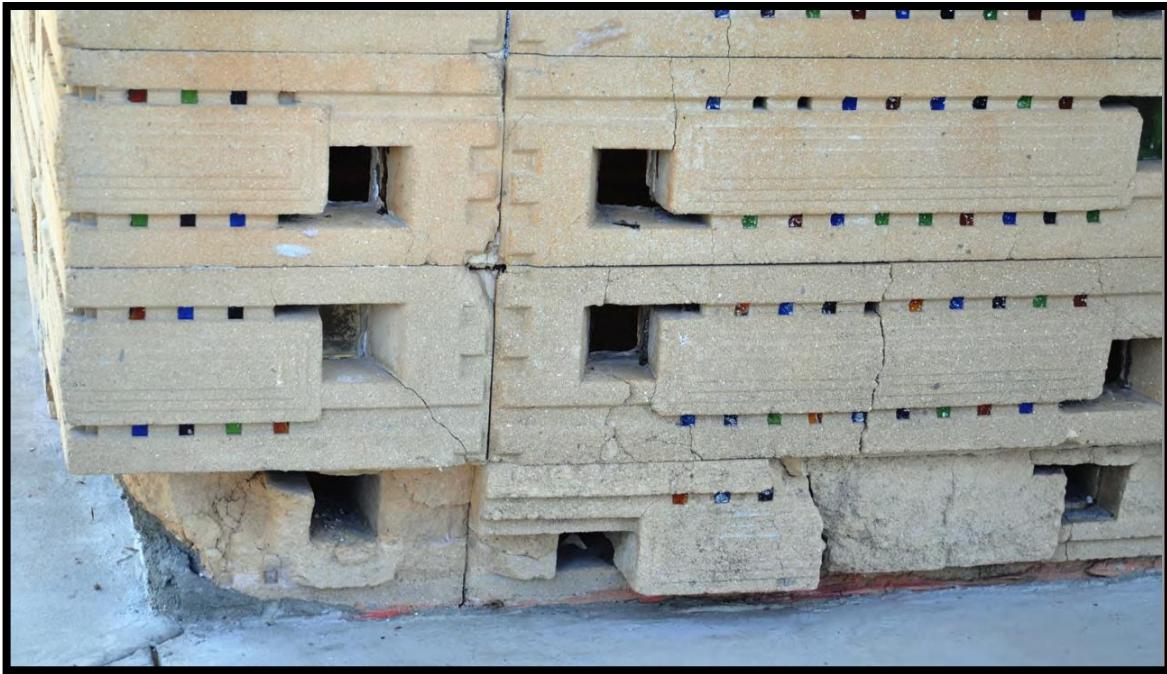
Fig. 32 Cracking, erosion and deterioration are unmistakable in this view of the corner of blocks. Surface water appears to be the leading cause of damage to the ground level. *Jeffrey M. Chusid, World Monument Fund.*

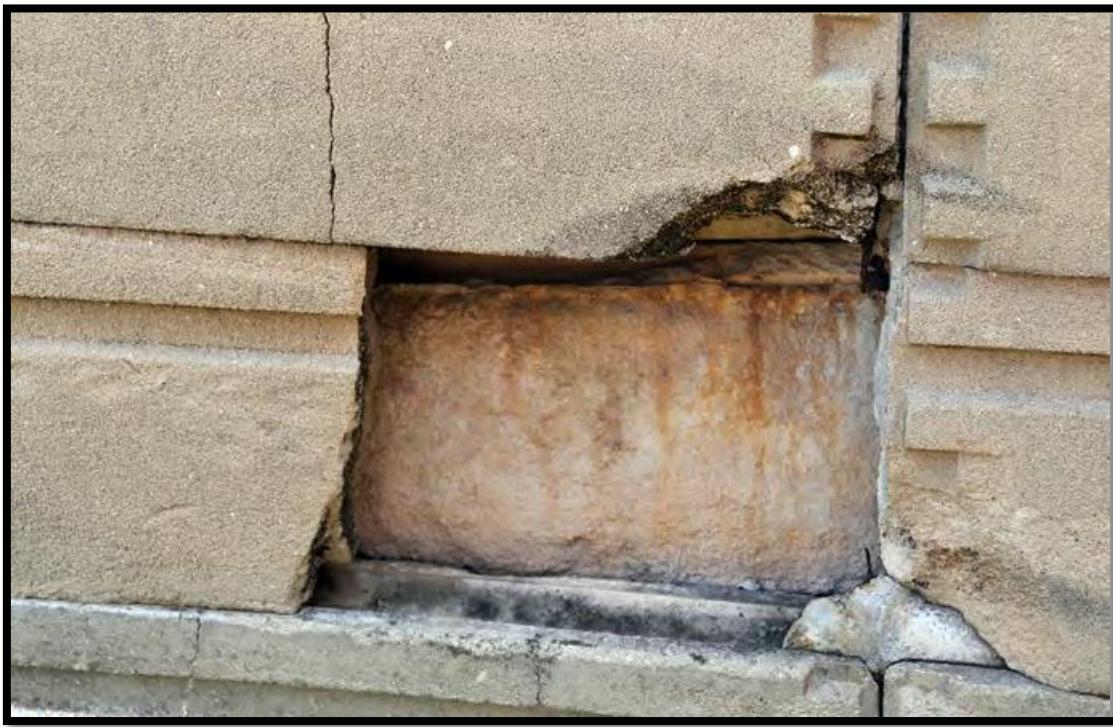
Fig. 33 Example of the facing separating from the block system. *Jeffrey M. Chusid, World Monument Fund.*

The system as a whole entity cannot function without the block, as it is the main component, but the block depends upon the support of the grout tubes and the steel reinforcements. Because of the porous material composition of the block, deterioration from excess moisture infiltration has lead to the demise of the steel reinforcement causing corrosion and rust. This creates spalling and expansion of the block which begins to compromise the entire system. As deterioration continues, the security of the reinforcements and grout tubes becomes endangered. This can lead to the block’s displacement and/or the separation of the block’s facings (Fig. 33). Baker adds, “Some of the problems with the structures came
