## 523 N. Donnelly Street

### Rehabilitation Proposal

Preservation Rehabilitation-HIPR-734-OL

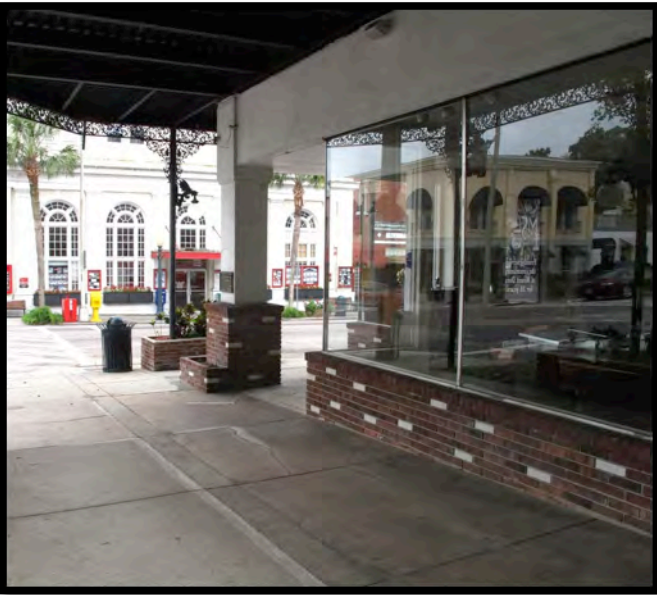
**Fig. 2.2** Main entrance on the corner of Donnelly Street looking towards Fifth Avenue. The spans of plate-glass and the designated office area of Main Street Leasing are to the right.

The exterior, continuous wall foundation is brick, while the interior foundation is comprised of concrete and metal with wood-clad columns atop a concrete foundation (Fig. 2.2).

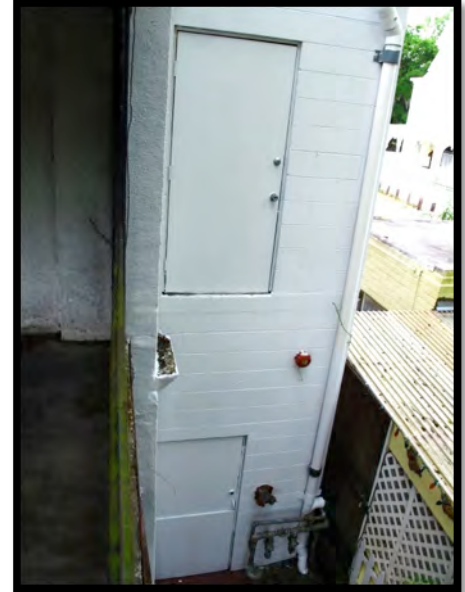
**Fig. 2.14** Access door on the second-floor of the east façade, facing Donnelly Street.

Just as there is a single entry, flat paneled metal exit door, measuring 3' x 6'-6", on the far right ground floor, of the north corner on Donnelly Street. There is an identical one right above it on the second floor facing Donnelly Street. It is also dead bolted with a single key lock and a pull bar to open (Fig. 2.14).

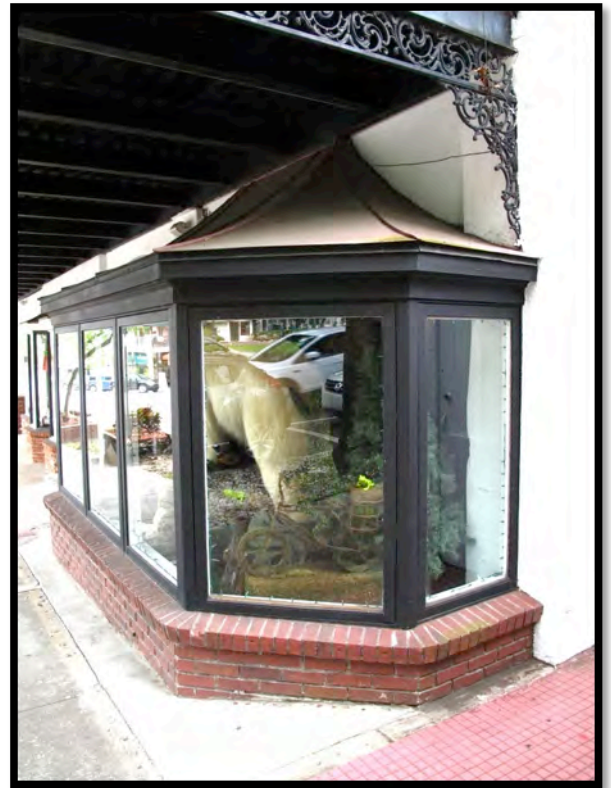
On the ground floor, facing Donnelly Street, 5' x 5' spans of plate-glass windows continue for 2 window spans (Fig. 2.11). Immediately following the windows are two 2' projected, plate-glass bay windows in aluminum-clad frames – two sets of three 2' x 5' windows joined by a 2' x 5' plate-glass window encased in an aluminum-clad frame (Fig. 2.11). After the bay windows is the secondary entrance, which is the enclosed former alcove. Two 3' x 4' spans of plate-glass windows flank the single entry, full glass door, while a 1' x 9' plate-glass transom sits above the two windows and door, with an arched transom of 2' radius x 9' base (all are encased in aluminum-clad frames) (Fig. 2.11). Immediately following this set of windows is another 4' projected, plate-glass bay window with two 2' x 4' windows and three 3' x 4' windows (also encased in aluminum-clad frames) (Fig. 2.17). All of these windows are in good condition.

**Fig. 2.17** One of the projected bay windows, this one is projected 4' east of the building towards Donnelly Street. A metal roof covers the extended bay window and an aluminum-cast framework sits atop a brick foundation.

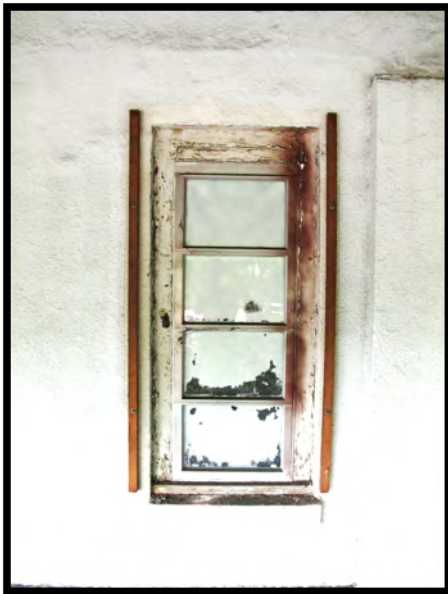
On the second floor, facing Donnelly Street, there are two 4' x 5' wood frames (originally plate-glass windows that have since been removed and boarded with plywood) on either side of the façade, flanking four 2-1/2' x 4' wood frames (originally four-paned wood windows) in the middle. Only two of the 2.5' x 4' four paneled, light paned windows remain and they are in poor and deteriorating condition (Fig. 2.18, 2.19). The other two windows have been boarded with plywood (Fig. 2.13).

**Fig. 2.18** One of the original windows that remains on the second-floor of the east façade.

Interior windows on the ground floor are in good condition, except for the two original windows that have been boarded with plywood on the southern side nearest to Fifth Avenue (Fig. 2.5). The windows on the second-floor are in very poor condition, at least those that are visible and not boarded (Fig. 2.18, 2.19), but majority of those that are covered in plywood are nothing more than deteriorating window frames.

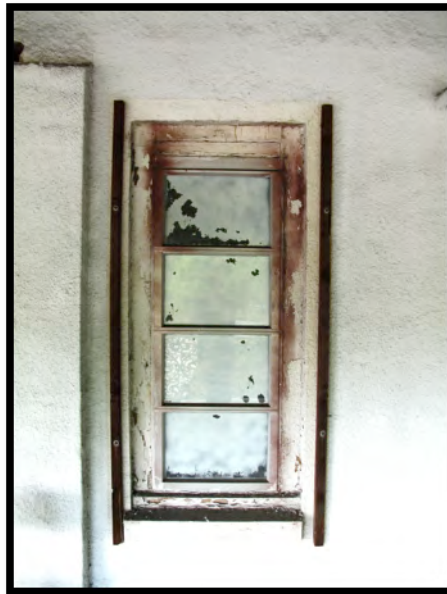
**Fig. 2.19** Second of the original windows that remain on the second-floor of the east façade.

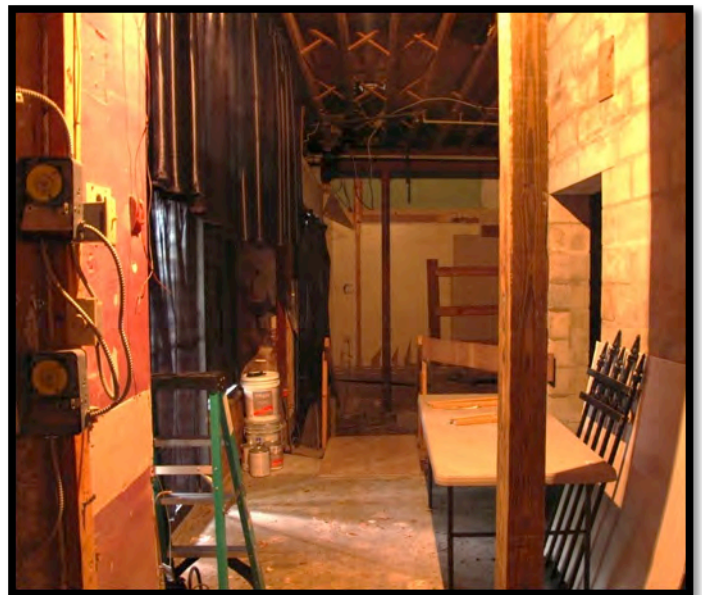
**Fig. 2.23** The secondary entrance from Donnelly Street is on the left and the newer concrete stairwell is to the right. The area to the front is the same as seen in Fig. 22.

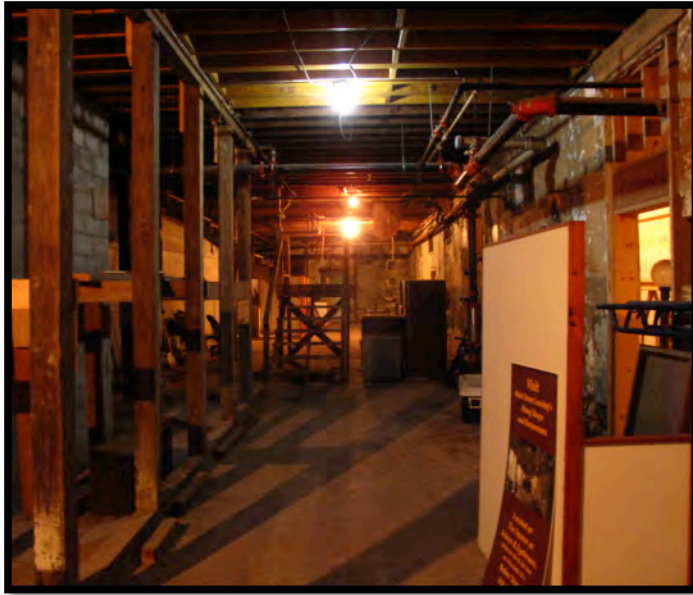
On the ground floor, the width of the building is divided into three sections by concrete block walls. The first section (Fig. 2.22) is located towards the south side of the building, measuring about 46' in width. The next section (Fig. 2.24) is about 22' in width and the final section (Fig. 2.25), on the north side of the building, is more like a utility area or emergency exit area measures about 7' in width.

**Fig. 2.24** Looking towards the back of the building and the makeshift wood staircase.

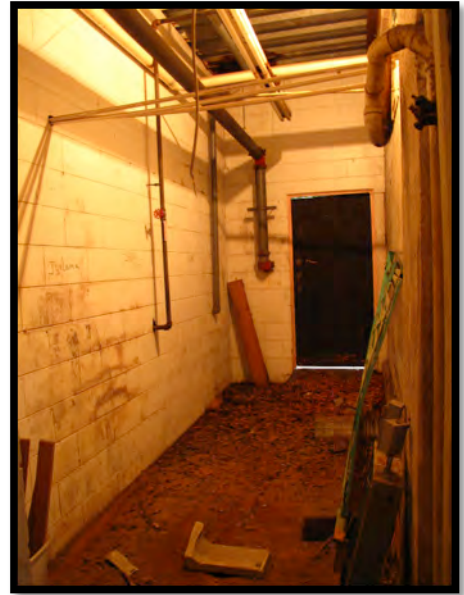
**Fig. 2.25** Storage/emergency exit space to the north side of the building with dirt floors, looking towards the access door.

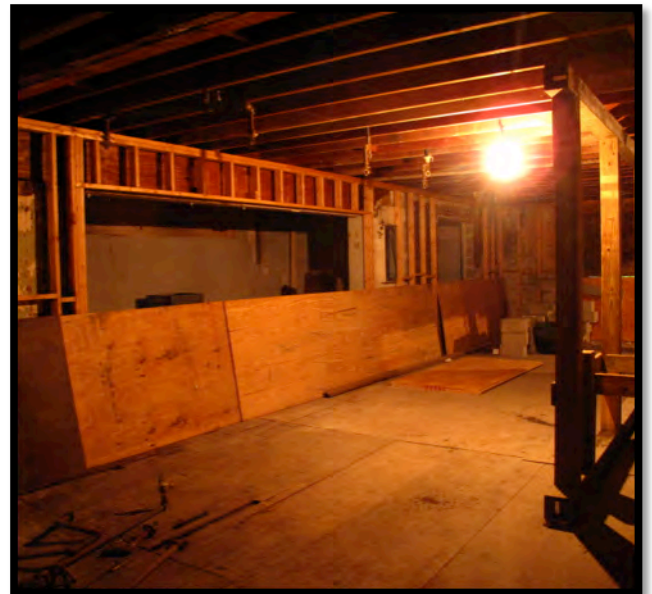
On the second-floor there are two sections (Fig. 2.26), the main expanse of the second floor that is about 68' wide and the utility/emergency exit area, to the north side of the building, which measures about 7' in width.

**Fig. 2.26** North wall on the second-floor. The storage/emergency exit is just beyond the opening in the wall.

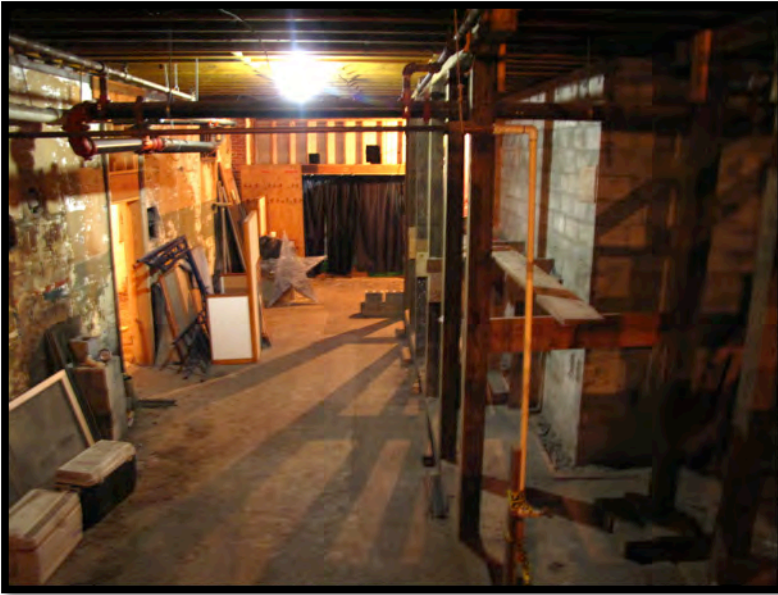
The original staircase has long been removed and the current wood staircase leading to the second-floor is makeshift (Fig. 2.28) as it was constructed for temporary access until the new staircase could be built; unfortunately it has been in existence since 2008. Construction had commenced on the concrete block encasement for the new stairway (Fig. 2.27) some years ago, but it has not been completed.

**Fig. 2.27** On the ground floor, looking towards the northeast corner of the building. The newer stairwell is to the right.

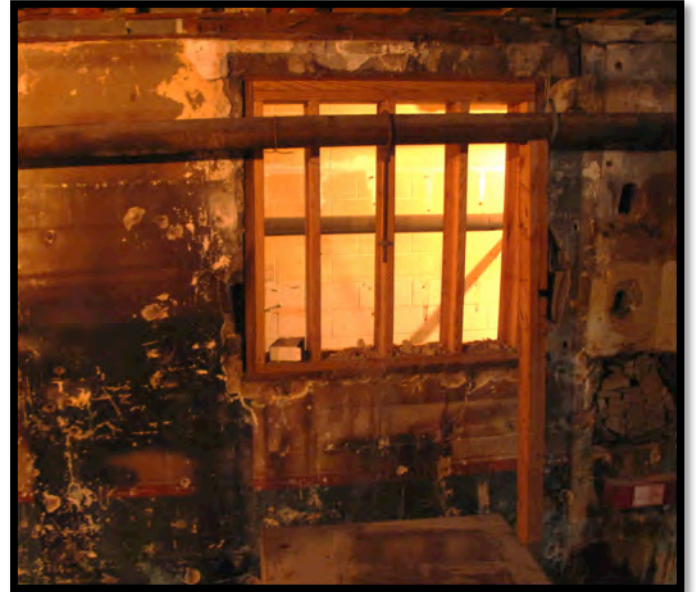
**Fig. 2.31** On the ground floor, looking towards the interior north wall.

The extensive water damage throughout the building has left the walls and ceilings completely unfinished (Fig 2.30 - 2.36). The walls are a hodge-podge of wallpapers and colors with the marks of water damage, while the ground floor ceiling is exposed to overhead joists and beams. The second-floor walls are in the same condition as the walls on the ground floor, and concrete blocks are visible in many parts of the building. The ceiling is completely unfinished, open to the joists and beams above. Only in the center of the open area is the original tin stamp ceiling.

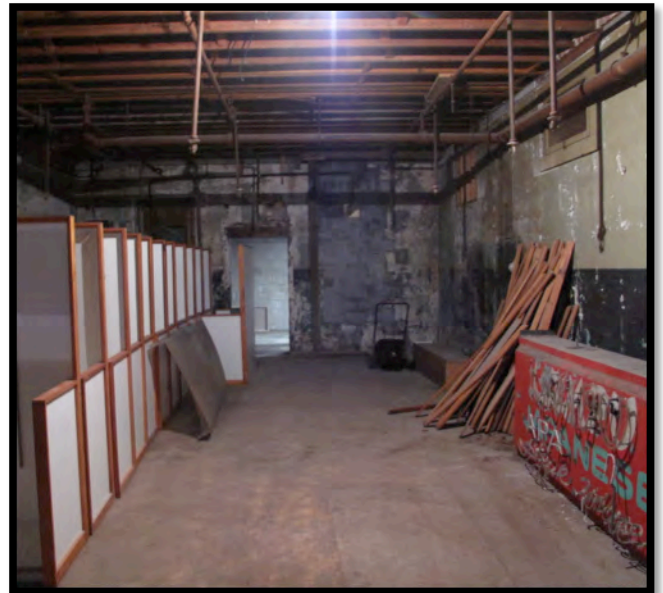
**Fig. 2.32** On the ground floor, in the middle of the space looking towards the west wall. The tin stamped ceiling remains in parts.

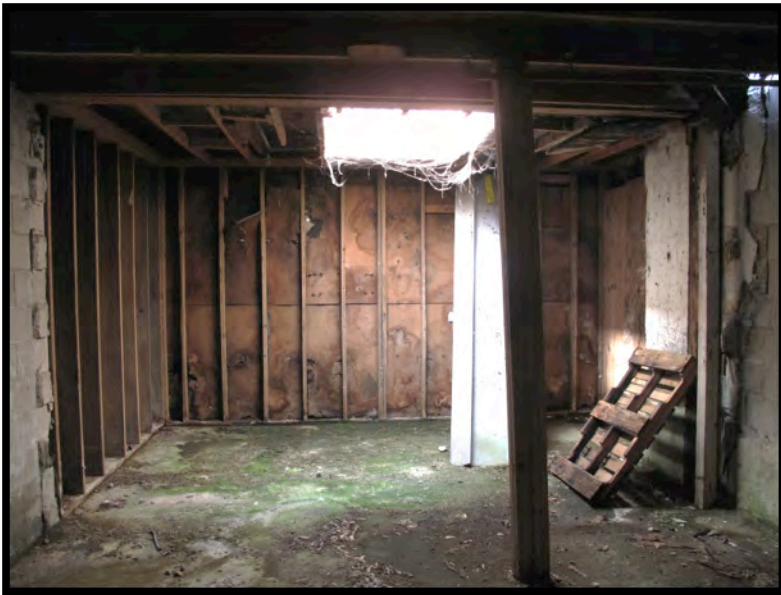
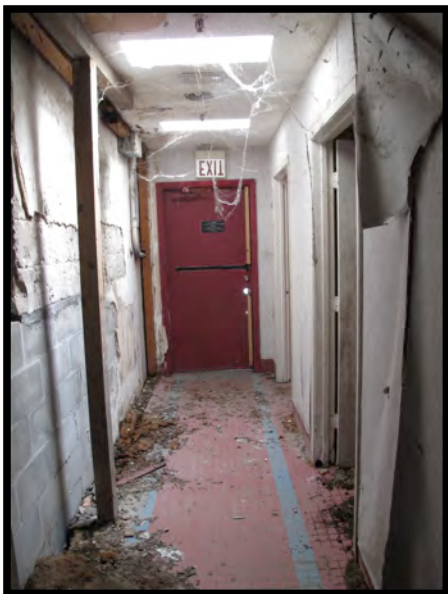
The only outbuilding is the one to the rear of the building, which is actually attached to the building through a hallway. It contains the bathrooms, storage space, as well as the rear access from the street level on Fifth Avenue (Fig. 2.37 – 2.40). It is in complete disrepair from the roof to the floors, and the walls to the bathrooms.

**Fig. 2.37** (left) On the ground floor in the connected outbuilding, facing the northwest corner.

**Fig. 2.38** (bottom left) In the connected outbuilding, facing the southwest corner and Fifth Avenue street level exit. Bathrooms are to the right.

**Fig. 2.39** (bottom middle) The women's bathroom, facing the west wall, has experienced extreme water damage.

**Fig. 2.40** (bottom right) The men's bathroom is also in deplorable condition.
