Annie M. Pfeiffer Chapel, Florida Southern College, Lakeland, Florida. *Robin Hill*,
<http://www.photoshopshowcase.com/ViewFlashMedia.aspx?AID=110446&AT=3>

Child of the Sun: A Crumbling History Preserved

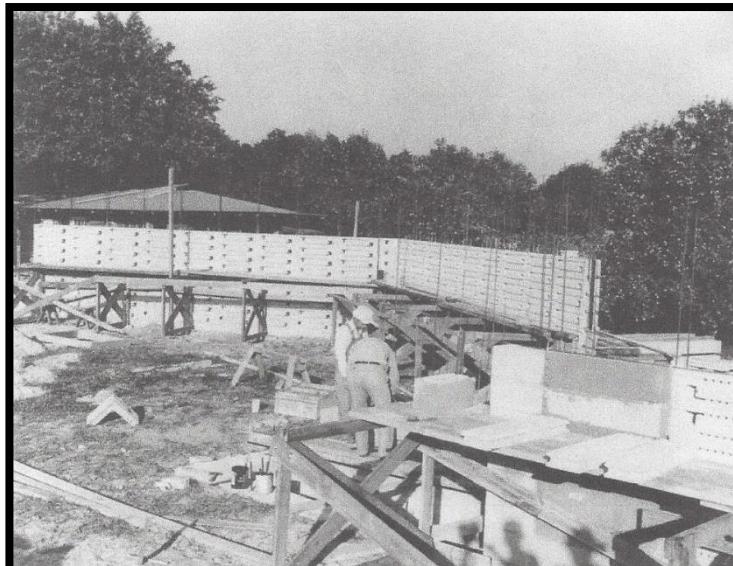
Fig. 9 Construction site of Annie M. Pfeiffer Chapel. Blocks stacked together vertically and horizontally with steel reinforcement. *The Frank Lloyd Wright Foundation, Photograph no. 3816.040*.

together.”¹⁶ This would later have negative consequences for many of the buildings on the campus, as this type of construction carried out by unskilled workers left too much room for error. The missing mortar bed made the alignment of the blocks uneven and the use of molds allowed slight variations within each block, which also caused issues with alignment, as well. Making the blocks allowed for great inaccuracies of color, quality and durability, as the mixtures used to create each block varied as there were so many different people mixing batches of material (Fig. 10, 11).

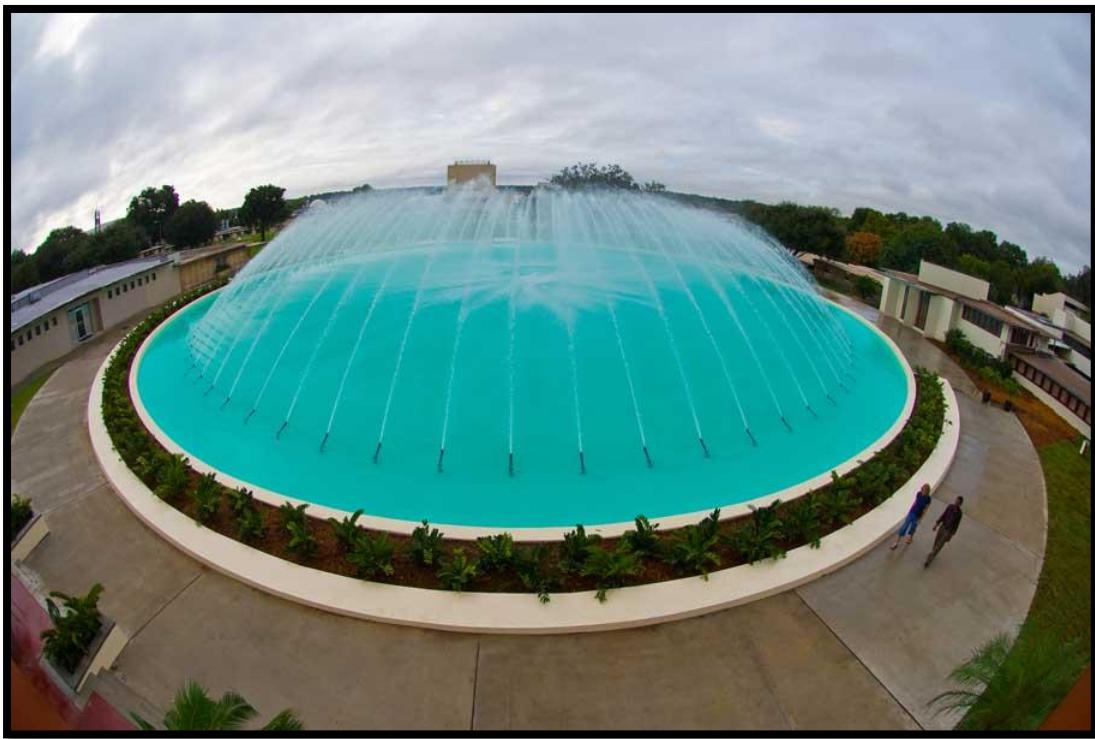
Fig. 16 Waterdome, partially completed in 1949, but never in proper working order. It was finally restored in 2006. *Florida Southern College*.

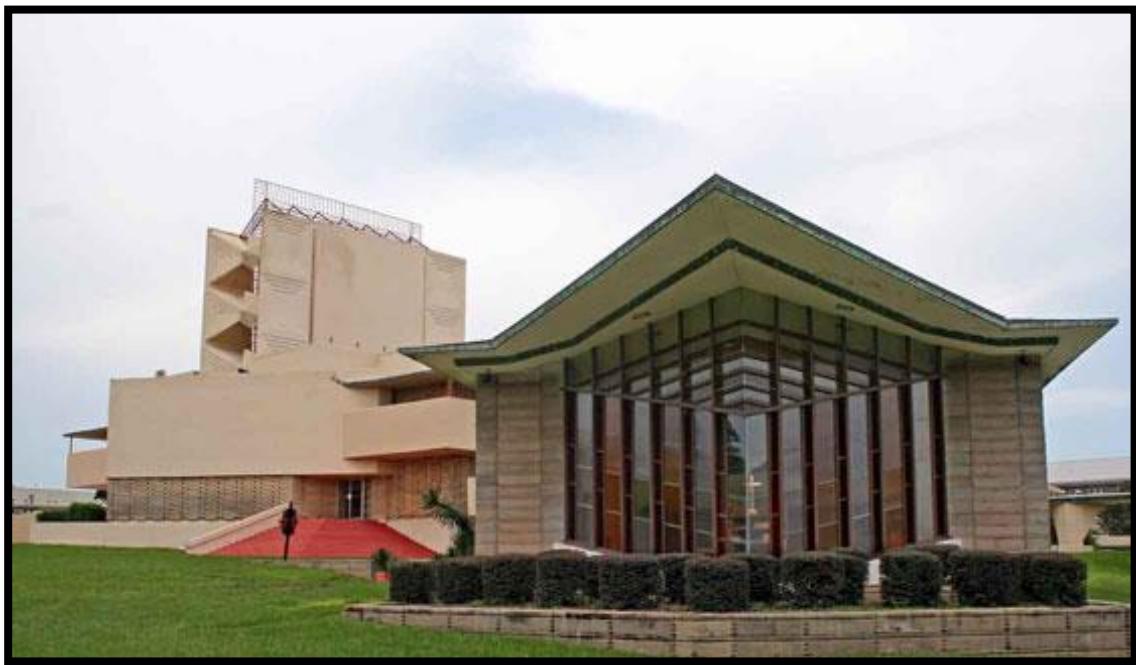
Fig. 24 William H. Danforth Chapel, completed in 1955, is the only leaded-glass composition designed by Wright. *Augustus Mayhew, The New York Social Diary*, <http://www.newyorksocialdiary.com/node/920187>.
